# UZ2400

## Low Power 2.4 GHz Transceiver for IEEE 802.15.4 Standard

### Errata

### ER-2400-01

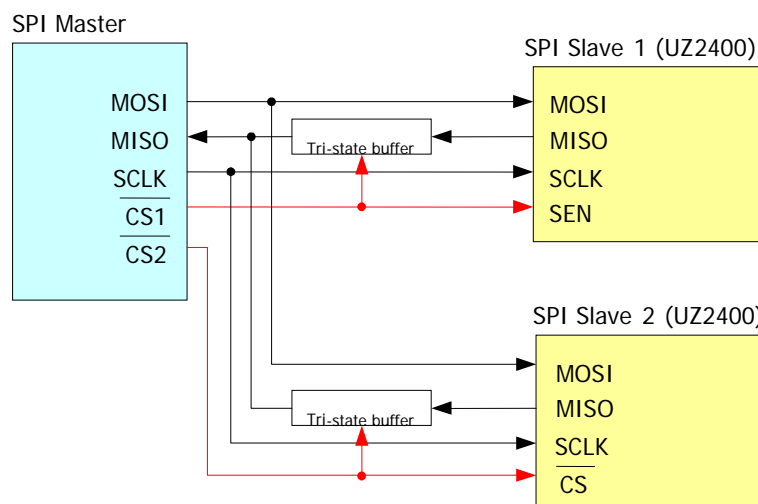
Figure 1. Multiple SPI slave connection

For the applications of multiple SPI buses, the output pin of MISO (master in, slave out) generally needs to be at high impedance state when it's disabled. While in UZ2400, the default state of MISO disable is at "low" state.

If multiple SPI buses are used, a tri-state buffer IC such as 74HC244 can be used at MISO output of UZ2400. The enabling signal of 74HC244 should be connected to the chip enable signal of slave SPI. A block diagram is shown in Figure 1. Multiple SPI slave connection.

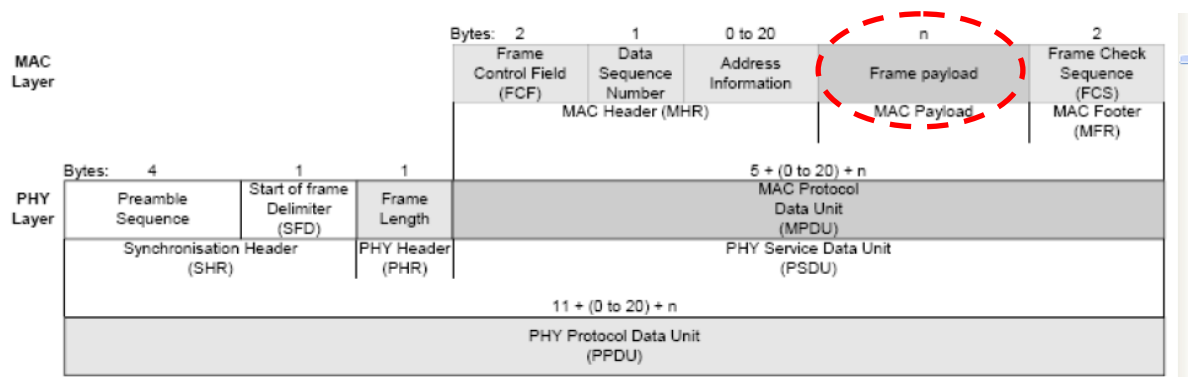
Under certain condition such as channel scanning, the UZ2400 receiver may receive unexpected packets at the 20MHz-spaced alternative channels if there are interfering sources whose intensities are sufficiently strong and whose locations are too close to the receiver. For instance, if the receiver is tuned to the 2425MHz channel, one could detect spurious signals at the 2405MHz, 2445MHz and 2465MHz alternative channels.

To prevent the system degradation due to the reception of unexpected packets caused by nearby sources, it is recommended that the user adds a "Channel ID" to the "Frame Payload" of the MAC layer (details of MAC layer structure please refer to Figure 2. Packet format for PHY and MAC or UZ2400 Datasheet DS-2400-02 V1.2 Section 3.2.1) Then the application software can filter out the unexpected packets and thus eliminate their impact to the system performance.
